PRIMARY RECORD

* Resource Name or #: 3203 Isla Vista Drive, APN 476-242-09

BUILDING, STRUCTURE, AND OBJECT RECORD

ISLENAIR HISTORICAL DISTRICT
CITY OF SAN DIEGO

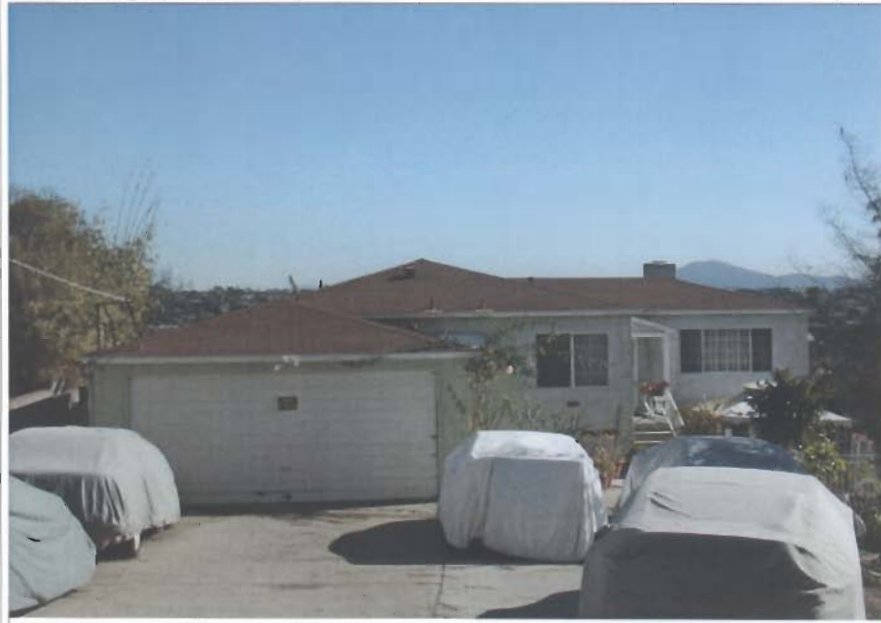
P5a. Photograph or Drawing (Photograph required for buildings, structures, and objects)

* P3a. Description: (Describe resource and its major elements. Include design, materials, condition, alterations, size, setting, and boundaries.)
The house at 3203 Isla Vista Drive was built in 1951 in the Minimal Traditional style with Split Level elements and features a multi-hipped roof with composition shingles; clipped eaves; and a textured stucco exterior. The entry porch, accessed via six concrete steps, is set to the right and features a roof extension supported by square wood posts. The entry door is set parallel to the sidewalk. Fenestration consists of 8-lite slider and 16-lite fixed vinyl frame and sash windows. Refer to BSOR Section B.6. for modifications and analysis of integrity.

Photo of the primary façade from the public right-of-way.

The house was constructed in 1951 per water and sewer records. Modifications include the replacement of the composition roof with a new composition roof, the use of textured stucco, and the replacement of the original wood windows with vinyl windows in enlarged openings. The house is in fair condition and retains a fair to poor degree of integrity.

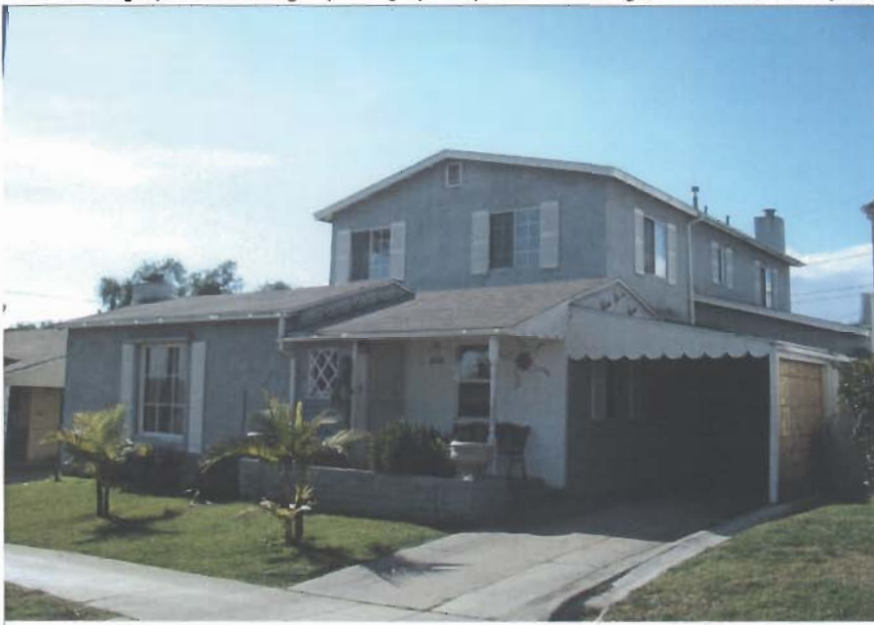
P5a. Photograph or Drawing (Photograph required for buildings, structures, and objects)

* P3a. Description: (Describe resource and its major elements. Include design, materials, condition, alterations, size, setting, and boundaries.)
The house at 3232 Isla Vista Drive was built in 1935 in the Minimal Traditional style and features a medium pitch side gable roof with composition shingles; clipped eaves; vertical wood siding in the gable end; and a textured stucco exterior. The entry porch, accessed via three concrete steps, is set to the right and features a roof extension supported by a turned spindle wood post. The entry door is set perpendicularly to the sidewalk. Fenestration consists of a nine-lite single pane fixed vinyl window and 4-over-4 double hung vinyl frame and sash windows. A carport has been added to the north side of the house and a front-facing gable second story addition has been added. Refer to BSOR Section B.6. for modifications and analysis of integrity.

Photo of the primary façade from the public right-of-way.

The house was constructed in 1935 per water and sewer records. Modifications include the replacement of the composition roof with a new composition roof; the use of textured stucco; the replacement of the original wood frame windows with vinyl windows; the addition of a carport; and the second story addition. The house is in good condition and retains a poor degree of integrity.

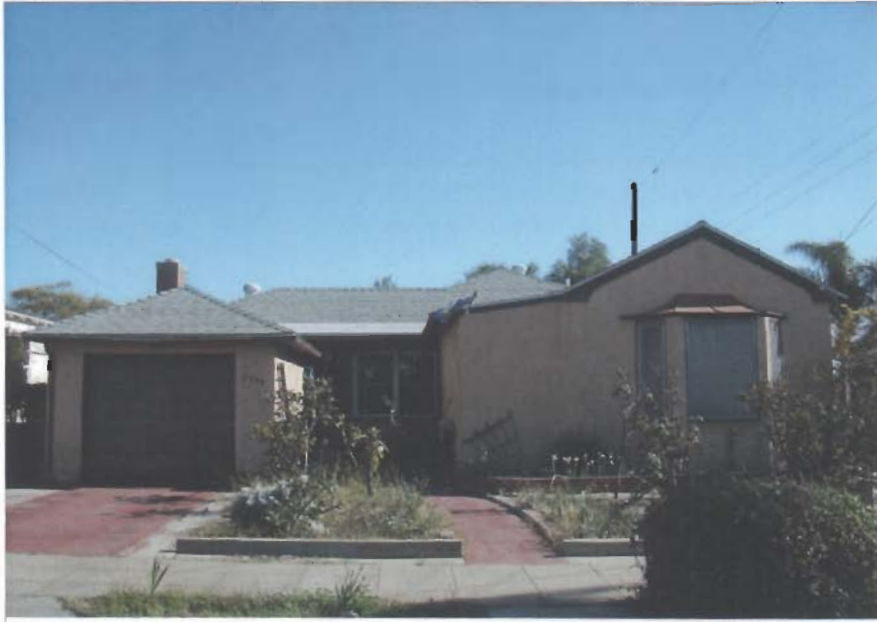
P5a. Photograph or Drawing (Photograph required for buildings, structures, and objects)

* P3a. Description: (Describe resource and its major elements. Include design, materials, condition, alterations, size, setting, and boundaries.)
The house at 3255 Isla Vista Drive was built in 1947 in the Minimal Traditional style and features a multi-hipped and gable roof with composition shingles; clipped eaves; and a textured stucco exterior. The entry is recessed behind a projecting front gable bay and a single car garage. The entry door is set parallel to the sidewalk. Fenestration consists of single pane fixed and 1-over-1 double hung aluminum frame and sash windows. The house appears to have undergone a number of additions and modifications, which have compromised the historic integrity of the structure. Refer to BSOR Section B.6. for modifications and analysis of integrity.

Photo of the primary façade from the public right-of-way.

The house was constructed in 1947 per water and sewer records. Modifications include several additions/alterations; the replacement of the composition roof with a new composition roof; and the replacement of the original windows with aluminum windows. The house is in fair condition and retains a poor degree of integrity.

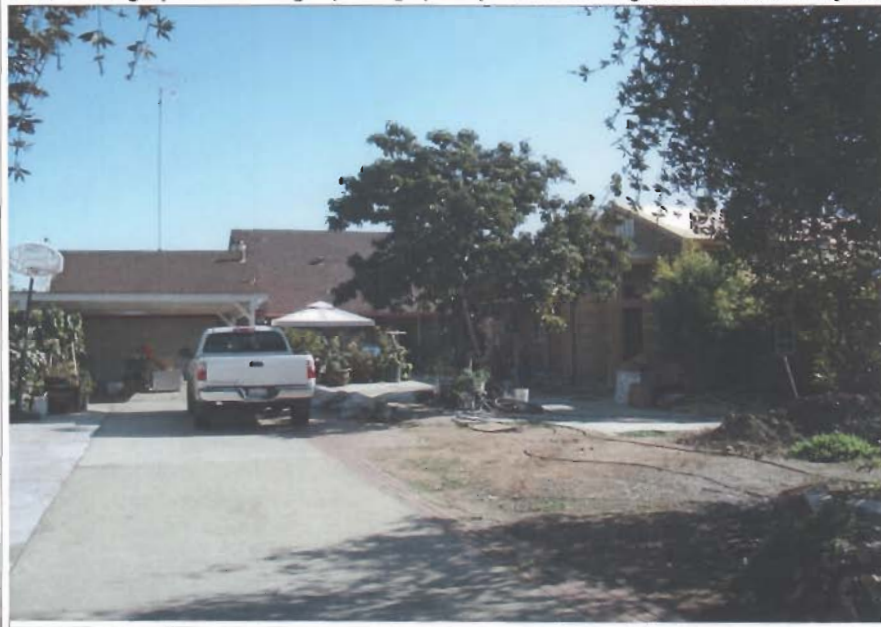
P5a. Photograph or Drawing (Photograph required for buildings, structures, and objects)

* P3a. Description: (Describe resource and its major elements. Include design, materials, condition, alterations, size, setting, and boundaries.)
The house at 3333 Isla Vista Drive was built in 1950 in the Ranch style and features a side gable roof with composition shingles; a slight eave overhang; and a concrete block exterior. The entry, which is at grade, is roughly centered under a roof projection supported by square wood posts. The entry door is set parallel to the sidewalk. Fenestration is not readily visible from the public right of way. A large addition at the front of the house is currently under construction. Refer to BSOR Section B.6. for modifications and analysis of integrity.

Photo of the primary façade from the public right-of-way.

The house was constructed in 1950 per water and sewer records. Modifications include the replacement of the composition roof with a new composition roof and a new, large addition at the front of the property which is not in keeping with the U.S. Secretary of the Interior's Standards. The house is in good condition and retains a poor degree of integrity.

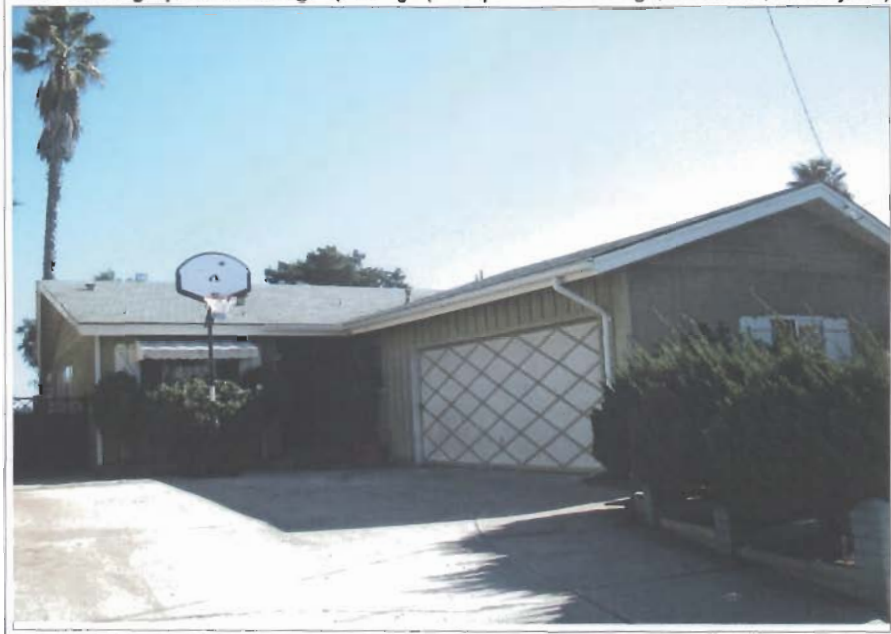
P5a. Photograph or Drawing (Photograph required for buildings, structures, and objects)

The house at 3411 Isla Vista Drive was built in 1957 in the Ranch style and features an "L" shaped floor plan with a dominant two-car garage; cross-gable roofs with composition shingles; wood clapboard siding in the gable end; a stucco and wood board and batten exterior; and a chimney at the east elevation. The entry, accessed via one concrete step, is recessed into the façade under a roof projection. The entry door is set parallel to the sidewalk. Fenestration consists of aluminum frame and sash fixed and slider windows with decorative wood shutters. Aluminum awnings have been added above a main window. Refer to BSOR Section B.6. for modifications and analysis of integrity.

Photo of the primary façade from the public right-of-way.

The house was constructed in 1957 per water and sewer records. Modifications include the replacement of the composition roof with a new composition roof; the replacement of some original wood frame windows with aluminum windows; and the use of aluminum awnings. The house is in good condition and retains a good degree of integrity.

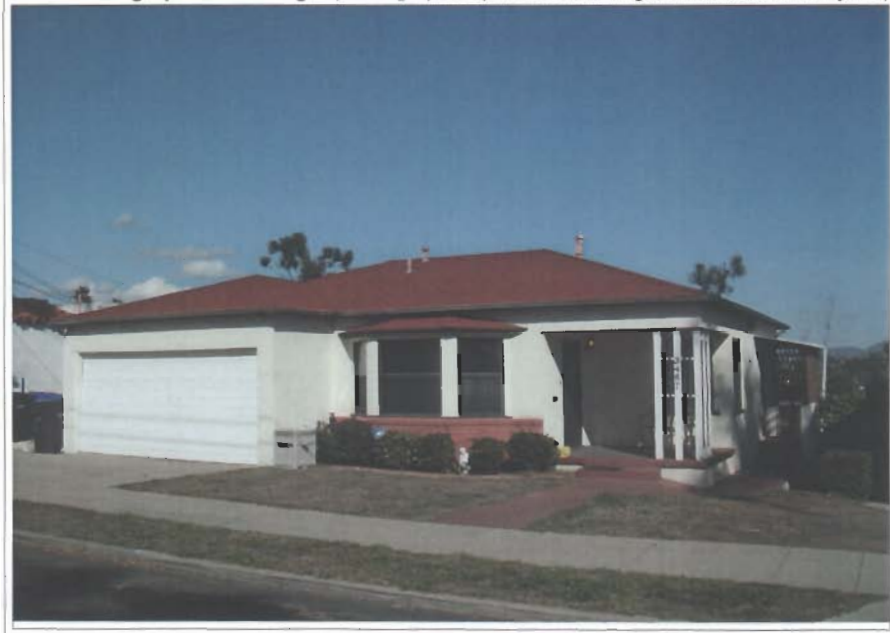
P5a. Photograph or Drawing (Photograph required for buildings, structures, and objects)

Photo of the primary façade from the public right-of-way.

The house was constructed in 1939 per water and sewer records. Modifications include the replacement of the composition roof with a new red composition roof; the replacement of the original wood frame windows with aluminum frame windows; the likely addition of the bay window; the use of brick veneer; the likely replacement of the wood porch post(s); and the replacement of the original garage door with a new wood door. The house is in good condition and retains a fair to poor degree of integrity.

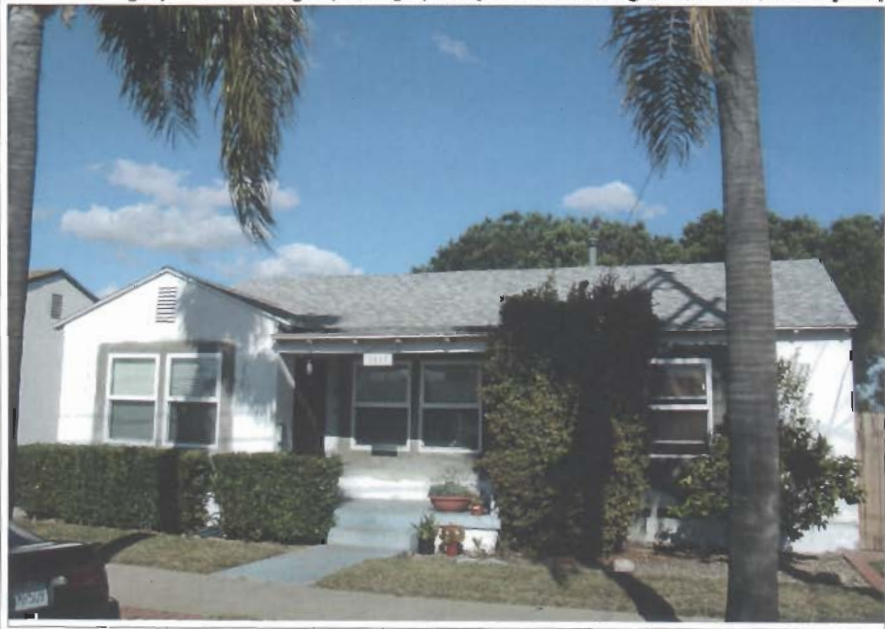
P5a. Photograph or Drawing (Photograph required for buildings, structures, and objects)

* P3a. Description: (Describe resource and its major elements. Include design, materials, condition, alterations, size, setting, and boundaries.)
The house at 3517 Isla Vista Drive was built in 1946 in the Minimal Traditional style and features a cross-gable roof with composition shingles; a slight eave overhang with exposed rafter tails; and a stucco exterior. The entry, accessed via two concrete steps, is set to the right of the bay under a roof projection. The entry door is set perpendicularly to the sidewalk. Fenestration consists of 1-over-1 double hung vinyl frame and sash windows in new and/or enlarged openings. Refer to BSOR Section B.6. for modifications and analysis of integrity.

Photo of the primary façade from the public right-of-way.

The house was constructed in 1946 per water and sewer records. Modifications include the replacement of the composition roof with a new composition roof; and the replacement of the original 6-over-6 wood frame windows with 1-over-1 vinyl frame windows in new and/or enlarged openings. The house is in good to fair condition and retains a fair to poor degree of integrity.

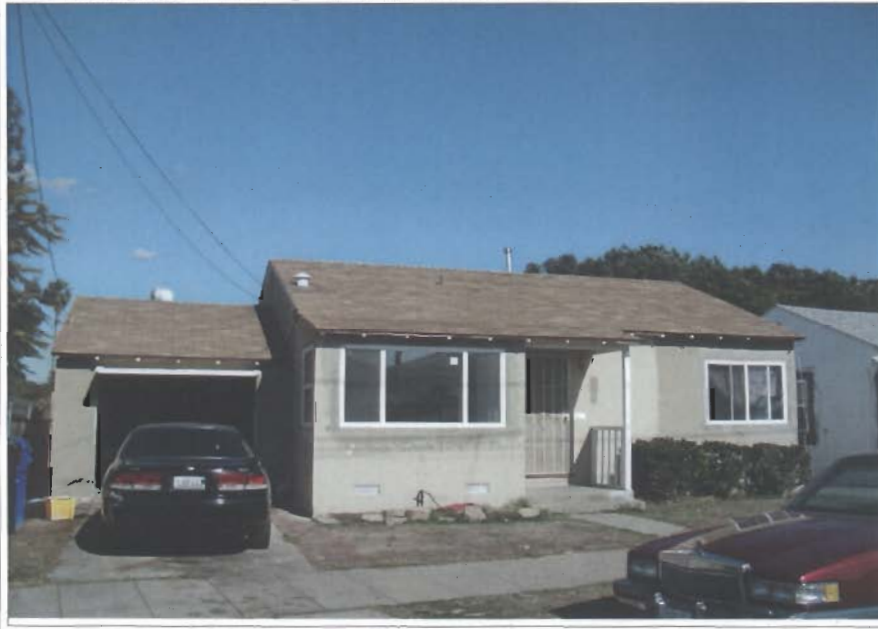
P5a. Photograph or Drawing (Photograph required for buildings, structures, and objects)

* P3a. Description: (Describe resource and its major elements. Include design, materials, condition, alterations, size, setting, and boundaries.)
The house at 3525 Isla Vista Drive was built in 1946 in the Minimal Traditional style and features a side gable roof with composition shingles; a slight eave overhang with exposed rafter tails; and a stucco exterior. The entry, accessed via two concrete steps, is set to the right of the bay under a roof projection supported by a wood post. The entry door is set parallel to the sidewalk. Fenestration consists of sliding vinyl frame and sash windows in new and/or enlarged openings. The single far garage is attached to the house and set back slightly from the main façade. Refer to BSOR Section B.6. for modifications and analysis of integrity.

Photo of the primary façade from the public right-of-way.

The house was constructed in 1946 per water and sewer records. Modifications include the replacement of the composition roof with a new composition roof; and the replacement of the original double hung and 16-lite fixed wood frame windows with sliding vinyl frame windows in new and/or enlarged openings. The house is in good to fair condition and retains a fair to poor degree of integrity.
